Lake Hall Lake Vegetation Index Results (7-21-2016)

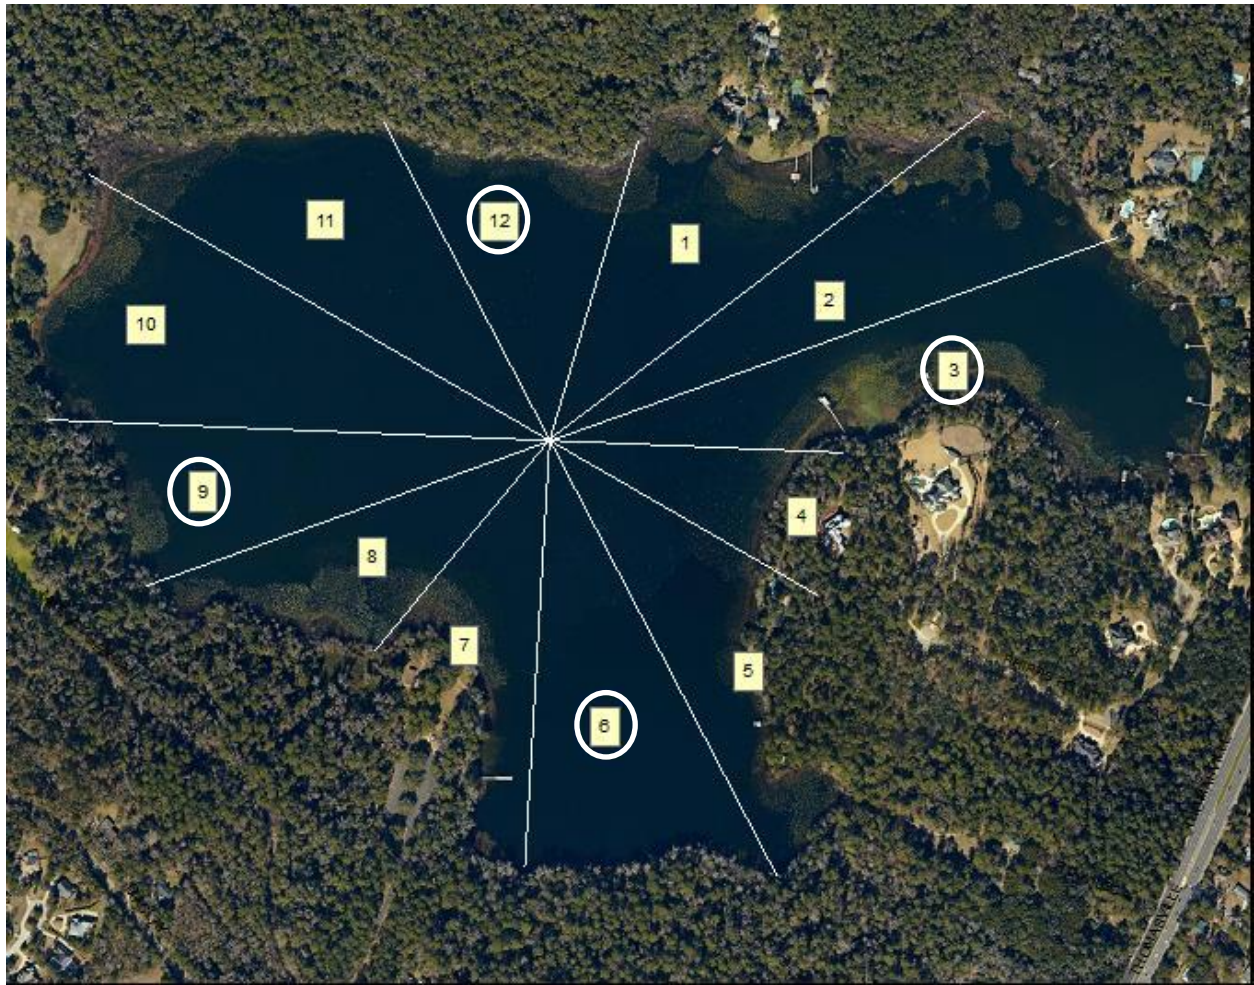
FIGURE 1. Lake Hall showing unit divisions. Circled numbers denote surveyed units.

The LVI method is performed from a boat, and involves dividing a lake into 12 units and identifying plants in 4 of the 12 units (Figure 1). Plants are identified in the selected unit by a visual boat "drive by" and also via a transect approach. The resulting data is used to calculate the LVI and is evaluated according to the scoring system in Table 1.
